# VDT Pipeline Integrity Solutions Pvt. Ltd.

# In Line Inspection Technology

# VDT In Line Inspection Technology

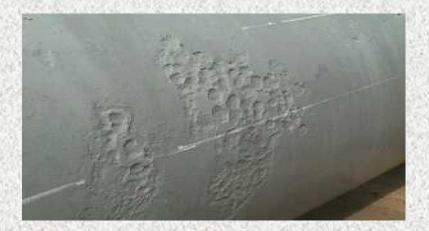
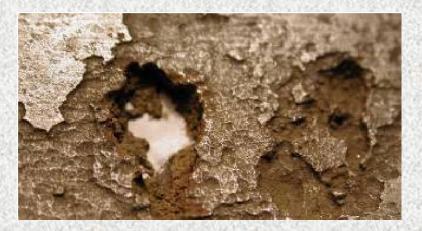
External corrosion

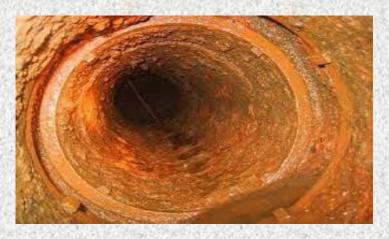
Internal corrosion

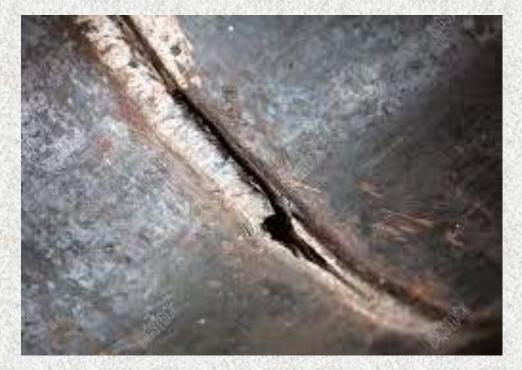
Weld cracks

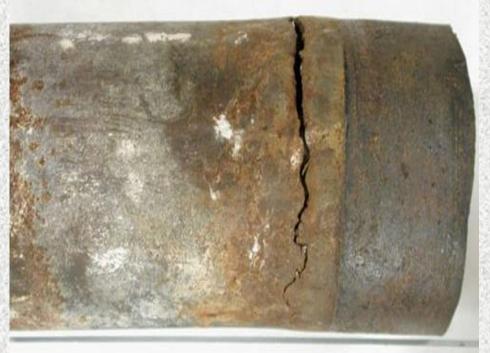
Fatigue cracks

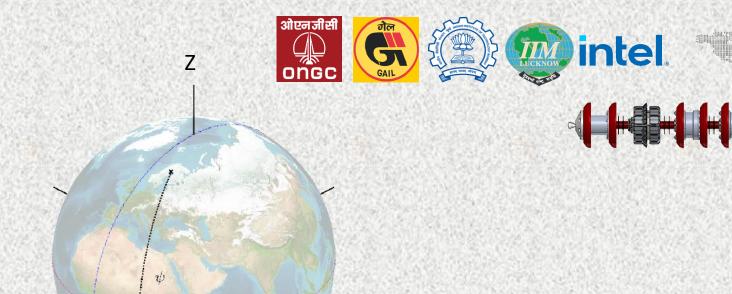
- Sub-centimeter survey data that was obtained prior to the inspection is plotted in Google Earth
- These survey points are paired with Above Ground Markers (AGMs) to help correct any IMU drift that occurs during the inspection
